NUREG/CR-4400
BNL-NUREG-51928

The Impact of Mechanical- and Maintenance-Induced Failures of Main Reactor Coolant Pump Seals on Plant Safety

Prepared by
M.A. Azarm, J.L. Boccio/BNL
S. Mitra/IC

Manuscript Completed: September 1985
Date Published: December 1985

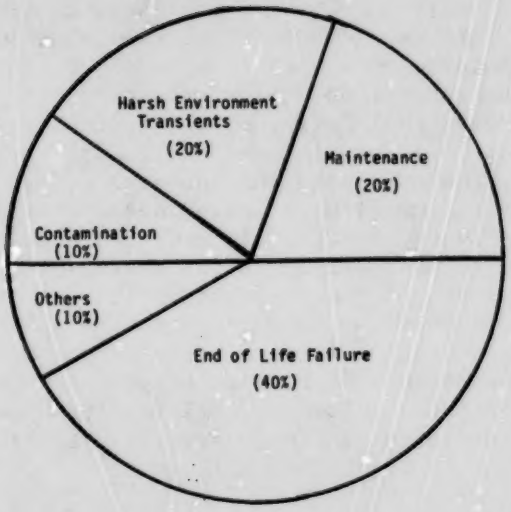
1) Root Cause Evaluation: In most cases, the cause of seal failures is determined on the basis of engineering judgment and some insight obtained from reviewing the event report. It is not unusual for multiple causes to be identified for a single event. Five major categories of root causes for seal failures identified in this study are: a) end-of-life seal failure (2)*; b) maintenance, fabrication, and installation errors (1,13); c) temperature and pressure transients (5, 7-9); d) seal contamination with crud or abrasive (6), and other causes as given in Table 1. A pie chart diagram representing the contribution of the aforenoted root causes is shown in Figure 2.

Figure 2. The contributions of various root causes to seal failures in PWRs.

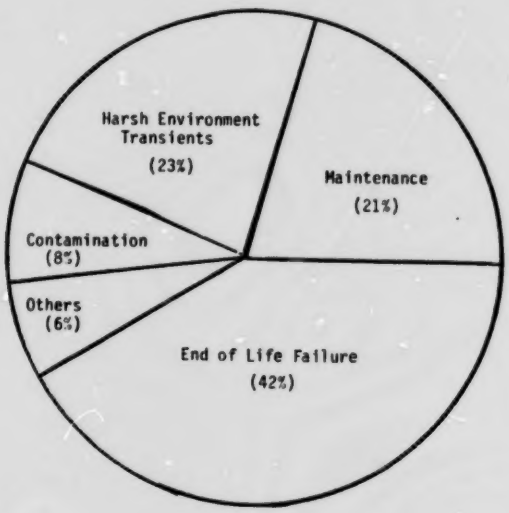
for creating a small LOCA. However, the evaluation of the seal problem and the corrective actions taken by the utility have virtually eliminated the possibility of recurrence. In addition, the contribution to core-melt frequency induced by small LOCA in BWRs is generally less than that for PWRs. Therefore, the risk associated with the recirculation pump seal leakage in the BWRs is judged to be negligible. The hazard rate estimated for recirculation pump seal failures in BWRs is about 1.3×10^{-2} per month. Failure attributed to seal wearout was ~42%, while 21% of the failures were judged to be maintenance induced. Harsh environments and plant transients accounted for 23% of the failures, while only 8% were attributed to the seal surface contamination.

Figure 3. The contributions of various root causes to seal failures in BWRs.

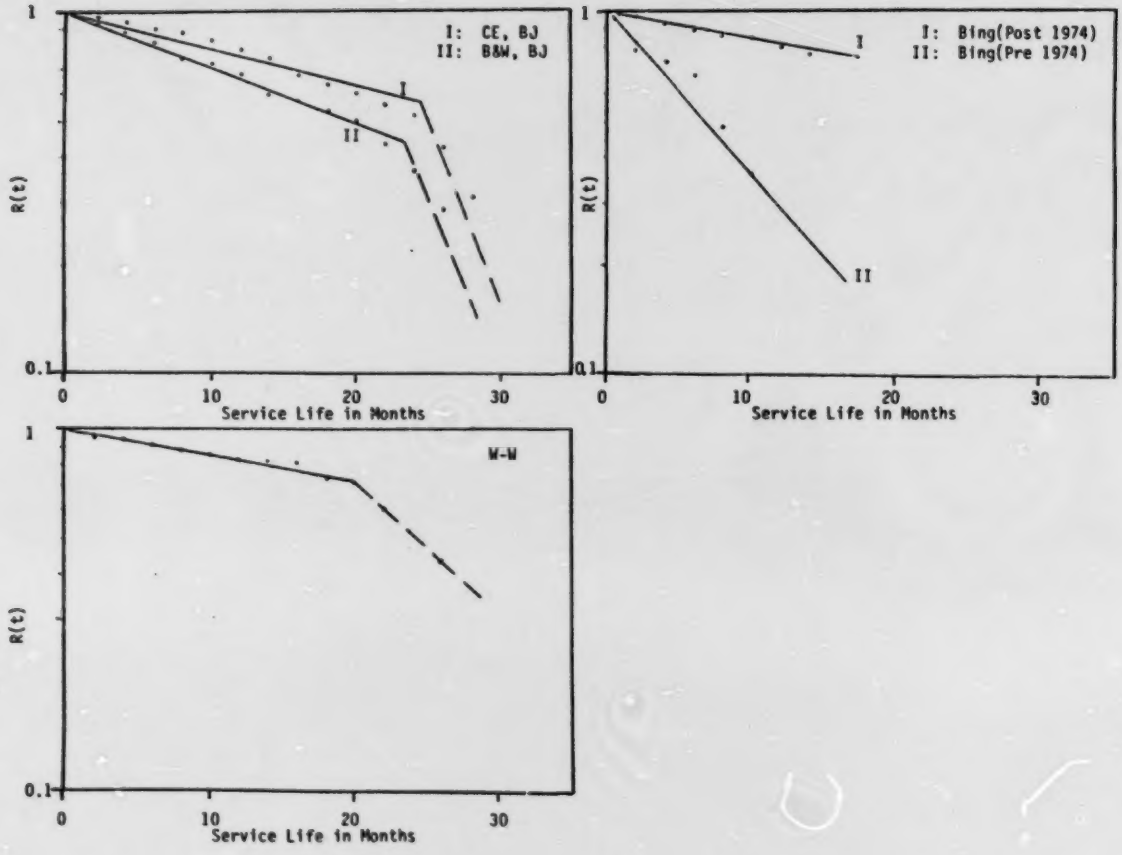
Figure 4. The reliability curves for various RCPs and PWR Plant Vendors.

The hazard rate used for seal failure to estimate the core-melt frequency in the remainder of this study is considered to be constant. The slopes of the graphs in Figure 4 are considered as the best estimate for the seal failure rates (for service life of less than 18 months). These values are given at the bottom of Table 5.

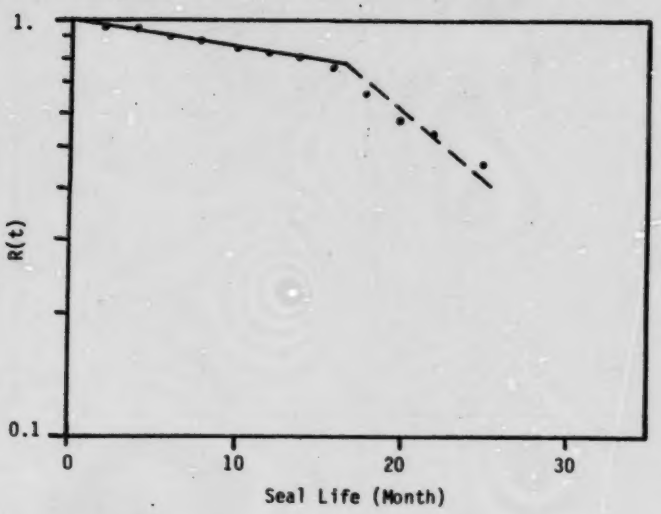
Figure 5. The reliability curve for the BWR recirculation pump seal failure.

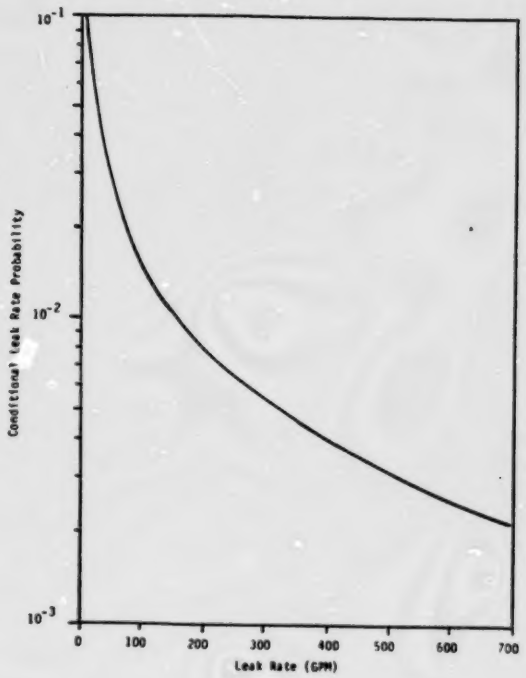
Figure 6. The conditional exeedance probability of leak rate given a RCP seal failure
